## Performance of bull bars in pedestrian impact tests

CASR REPORT SERIES

CASR020

July 2006

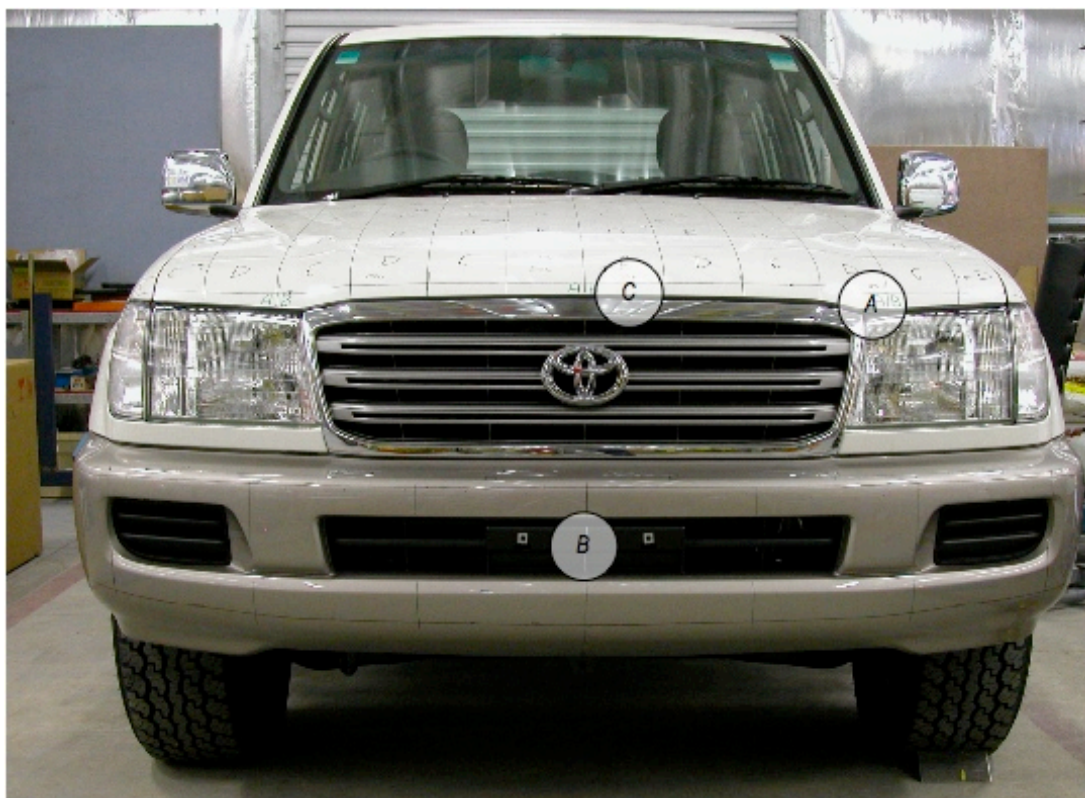
Figure 3.1  
Toyota Landcruiser test locations. Letters correspond to test locations for Part A, B and C tests

The bull bars and the impact locations for each test are illustrated in Figure 3.1 to Figure 3.16.

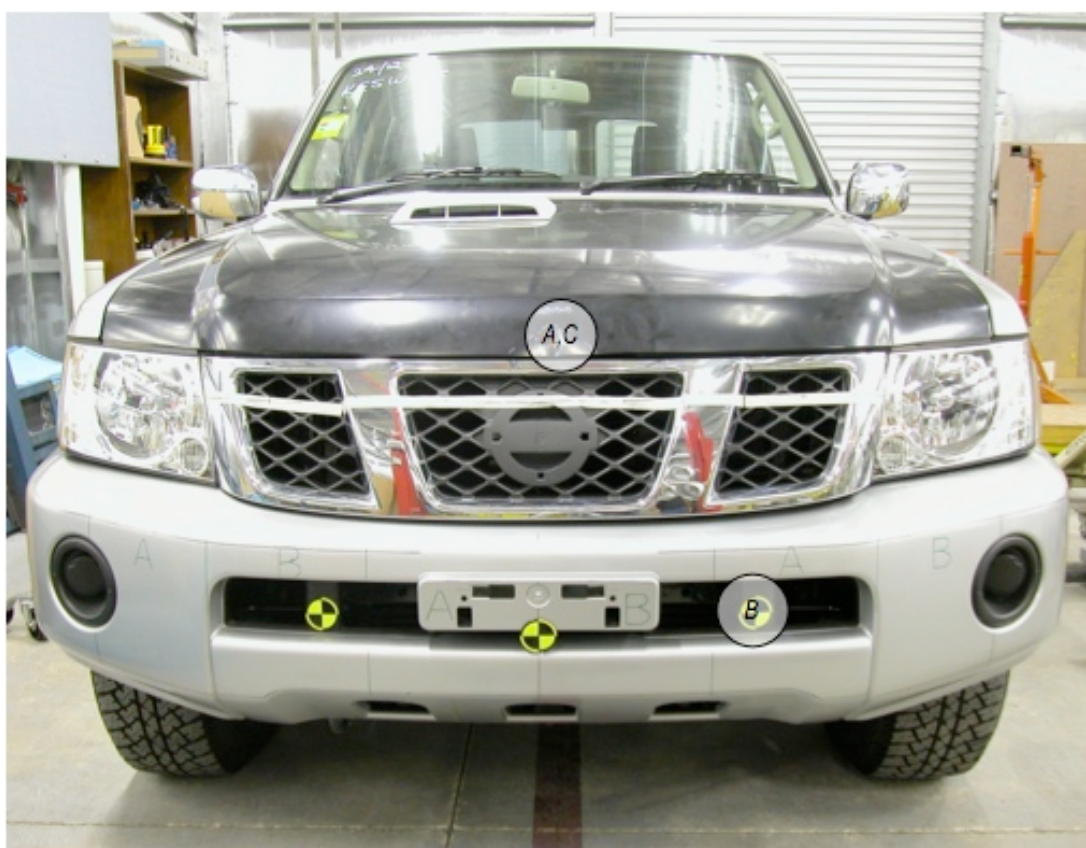
Figure 3.4  
Nissan Patrol test locations. Letters correspond to test locations for Part A, B and C tests

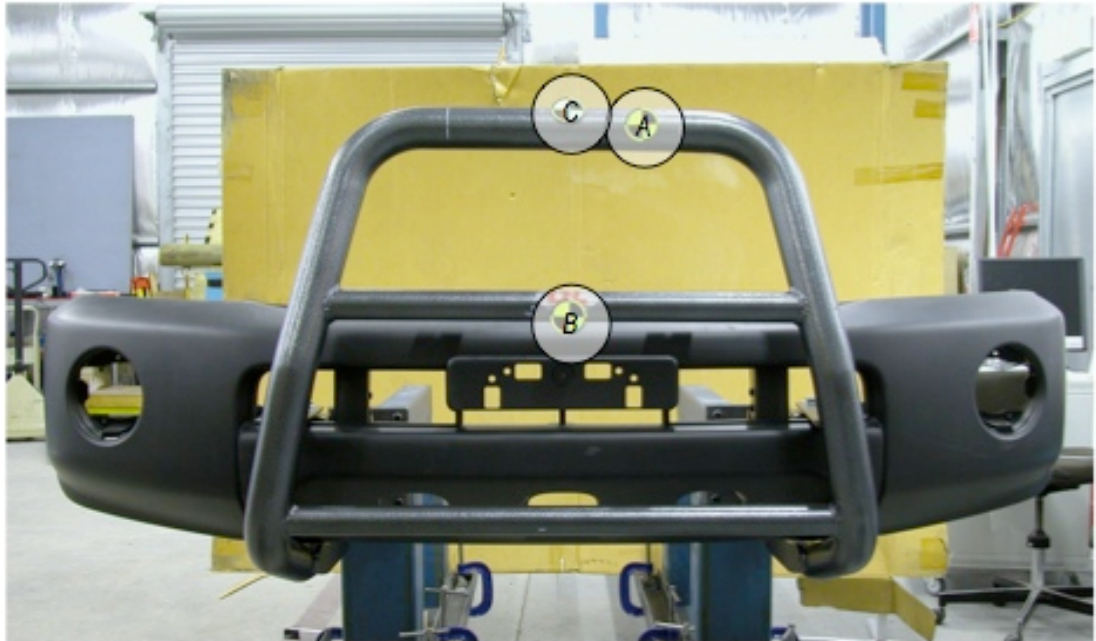
Figure 3.5  
Nissan Patrol aftermarket alloy / aluminium nudge bar test locations.  
Letters correspond to test locations for Part A, B and C tests

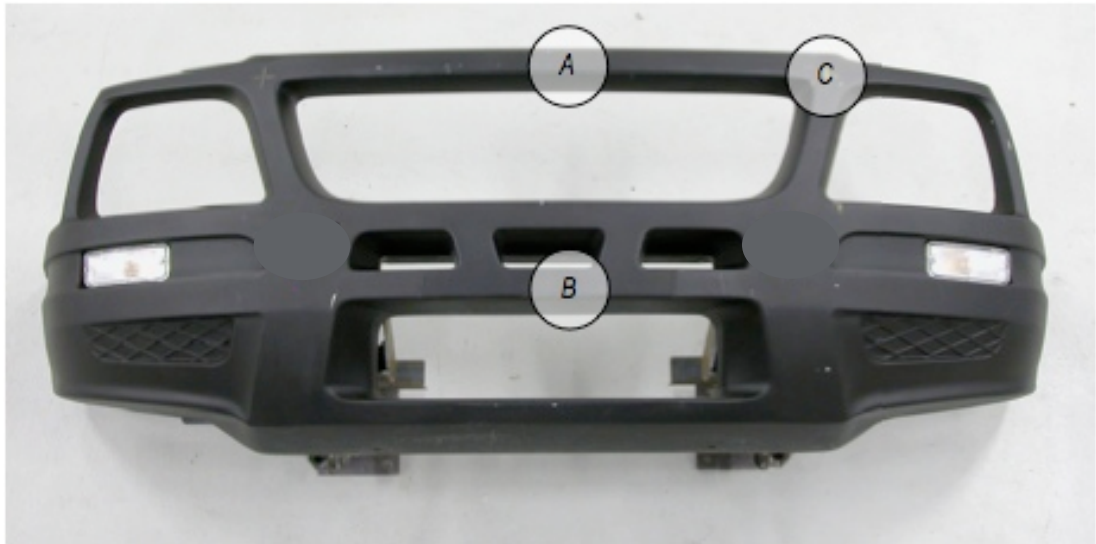
Figure 3.7  
Nissan Patrol aftermarket polymer bull bar test locations.  
Letters correspond to test locations for Part A, B and C tests

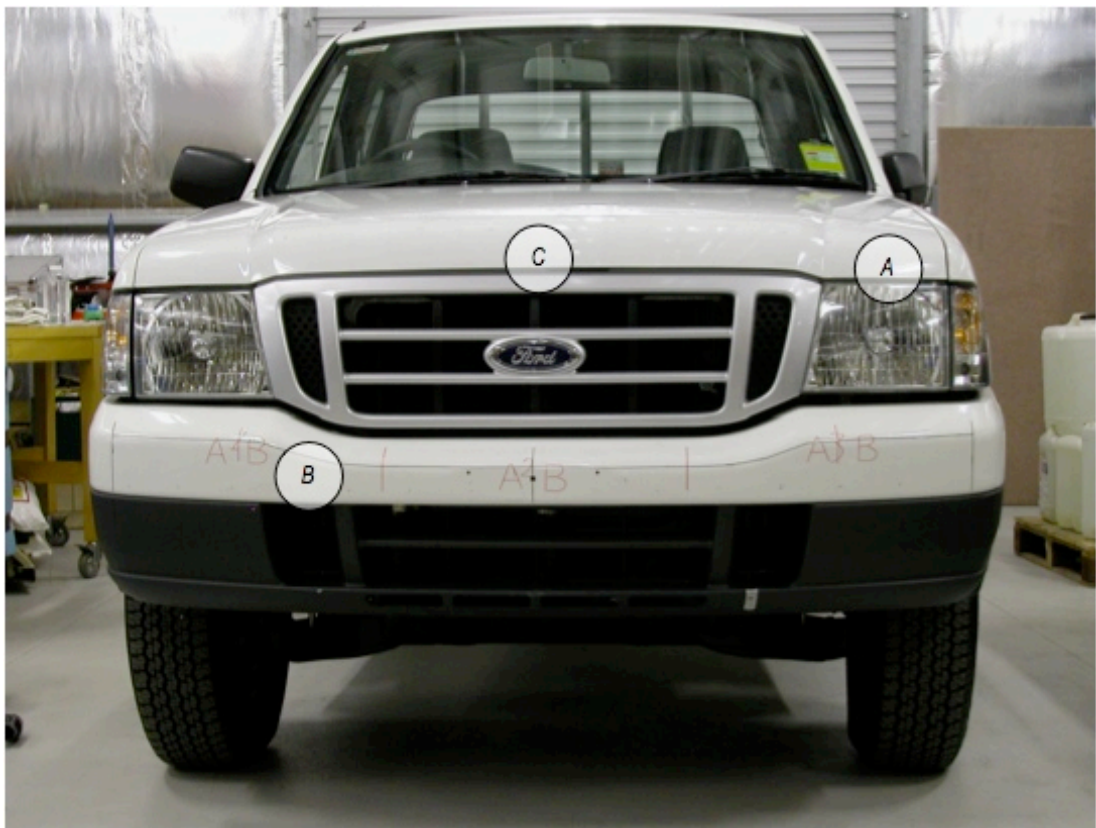
Figure 3.8  
Ford Courier test locations. Letters correspond to test locations for Part A, B and C tests

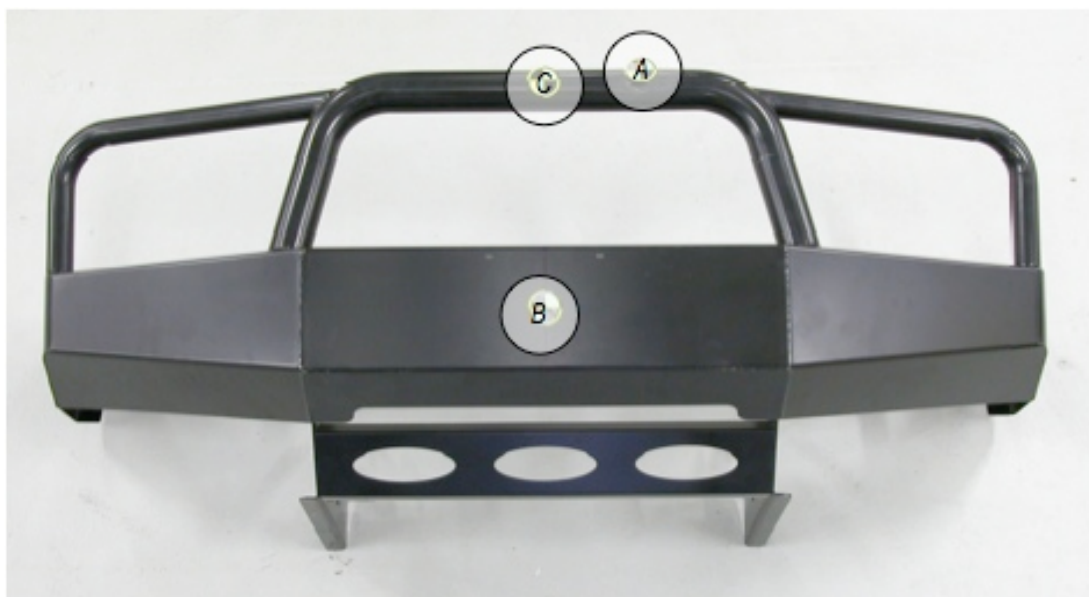
Figure 3.9  
Ford Courier aftermarket steel bull bar test locations.  
Letters correspond to test locations for Part A, B and C tests

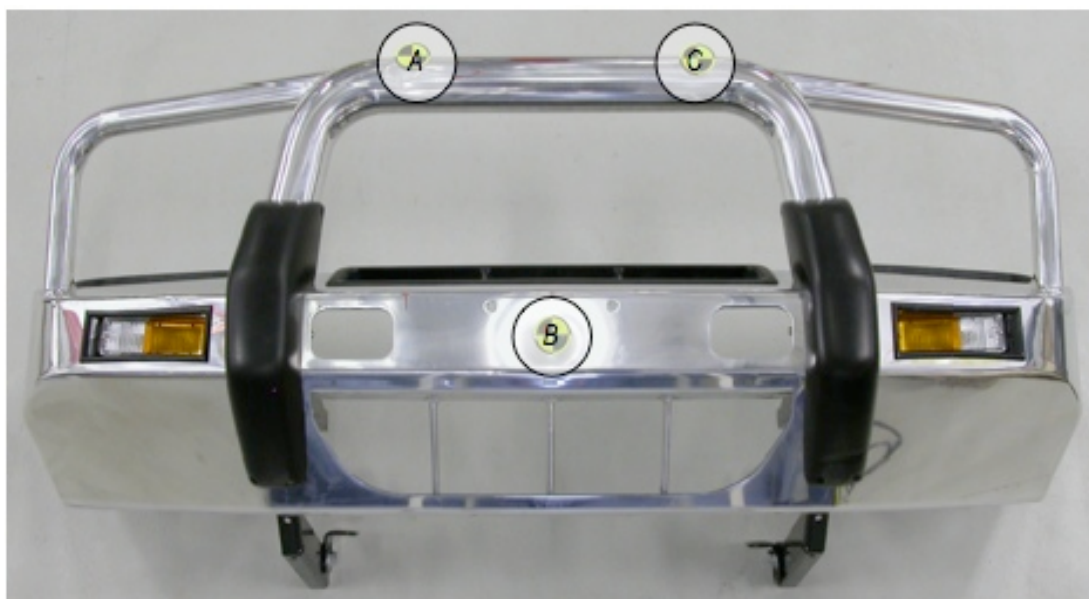
Figure 3.10  
Ford Courier OES alloy / aluminium bull bar test locations.  
Letters correspond to test locations for Part A, B and C tests

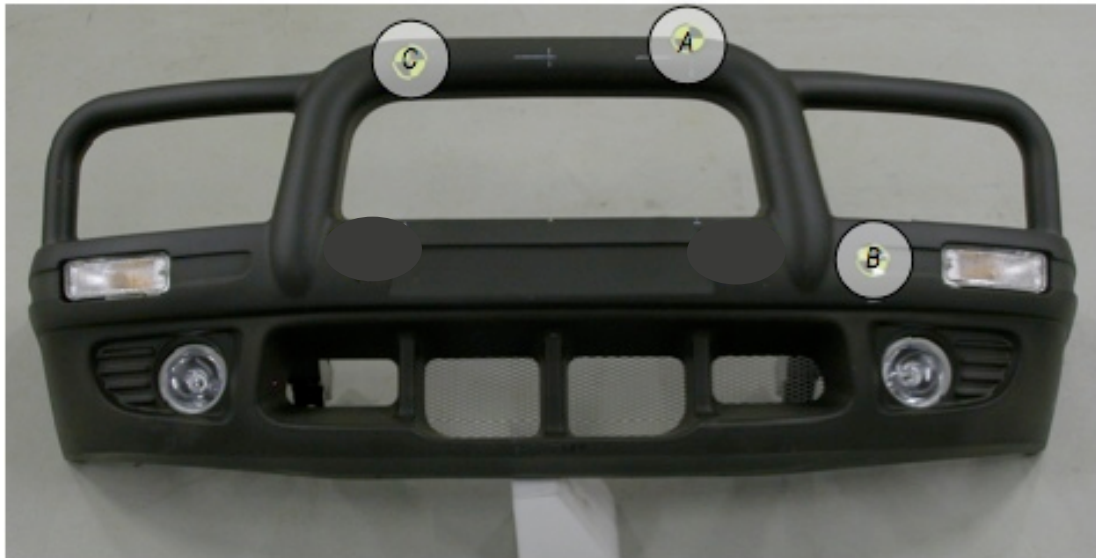
Figure 3.11  
Ford Courier aftermarket polymer bull bar test locations.  
Letters correspond to test locations for Part A, B and C tests

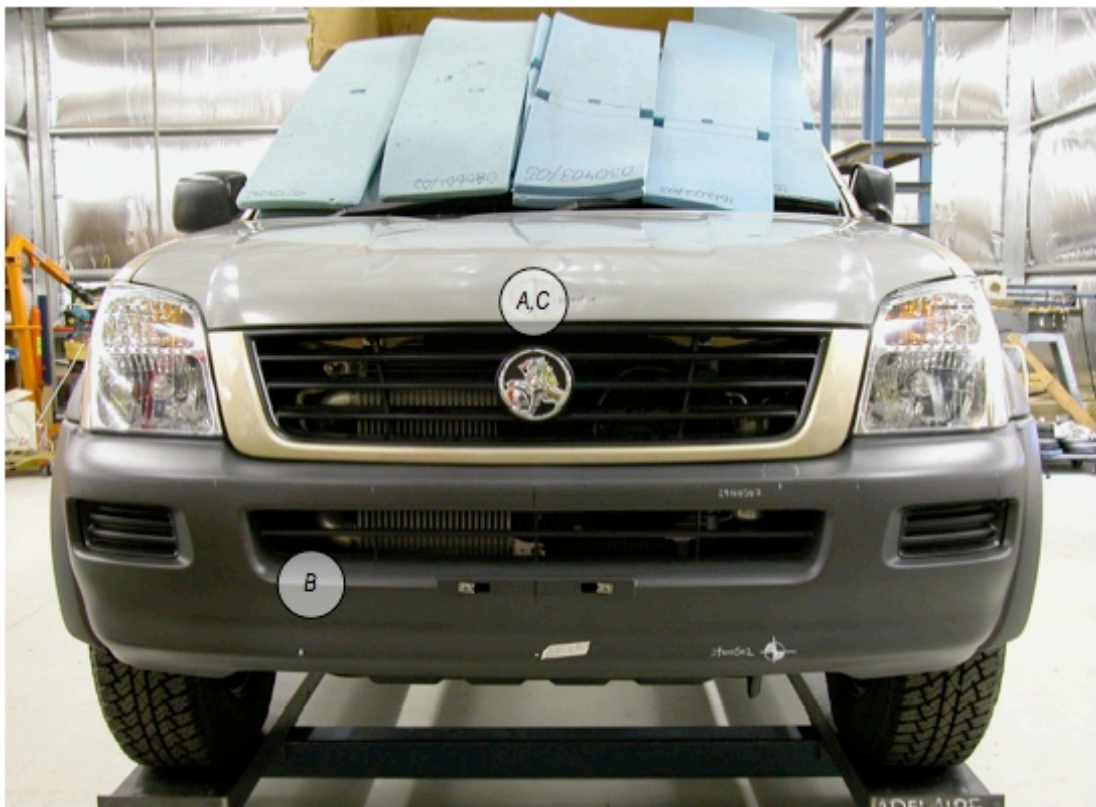
Figure 3.12  
Holden Rodeo test locations. Letters correspond to test locations for Part A, B and C tests

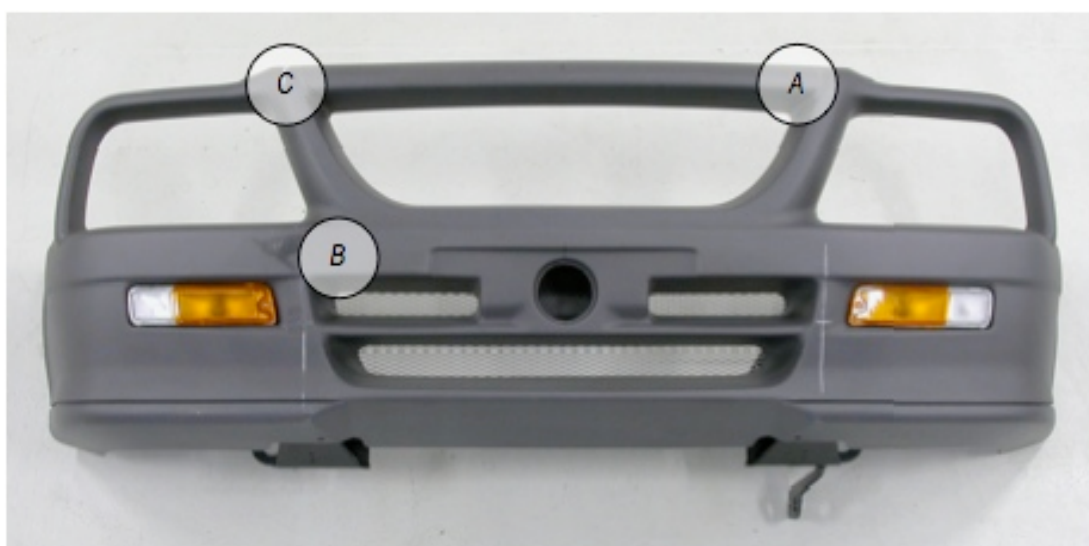
Figure 3.14  
Holden Rodeo aftermarket polymer bull bar test locations.  
Letters correspond to test locations for Part A, B and C tests

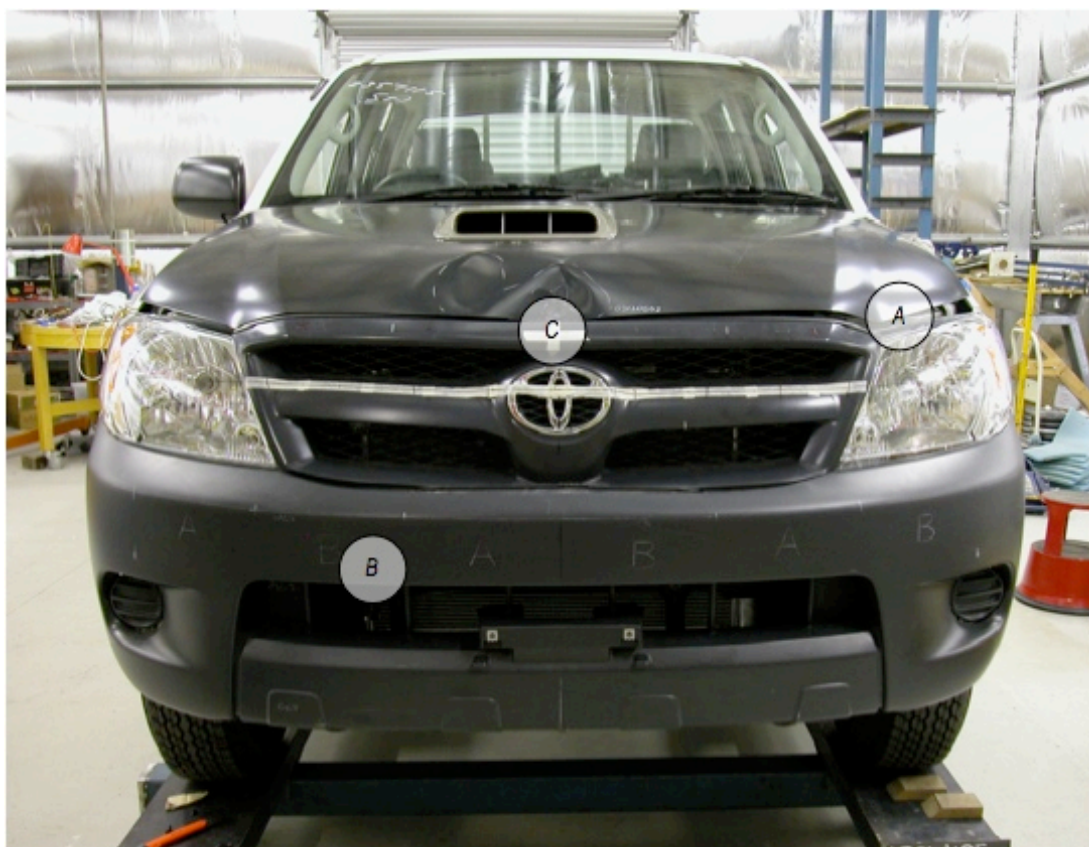
Figure 3.15  
Toyota Hilux test locations. Letters correspond to test locations for Part A, B and C tests

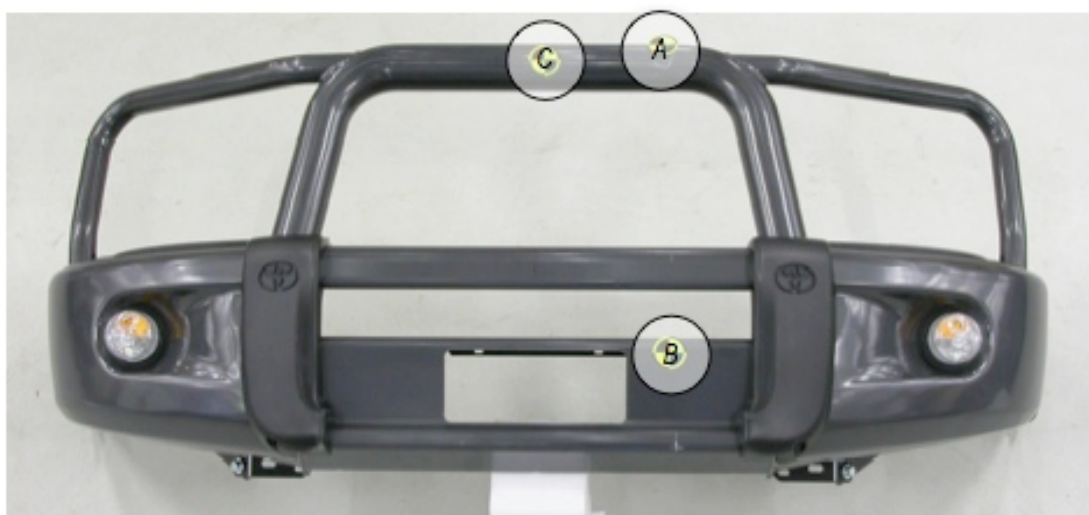
Figure 3.16  
Toyota Hilux OES steel bull bar test locations.  
Letters correspond to test locations for Part A, B and C tests
